# AIR FORCE MISSILE DEVELOPMENT CENTER TECHNICAL REPORT

WEAR, SOLID LUBRICATION, AND BEARING MATERIAL  
INVESTIGATION FOR HIGH-SPEED TRACK APPLICATIONS

Milton R. Wolfson

March 1960

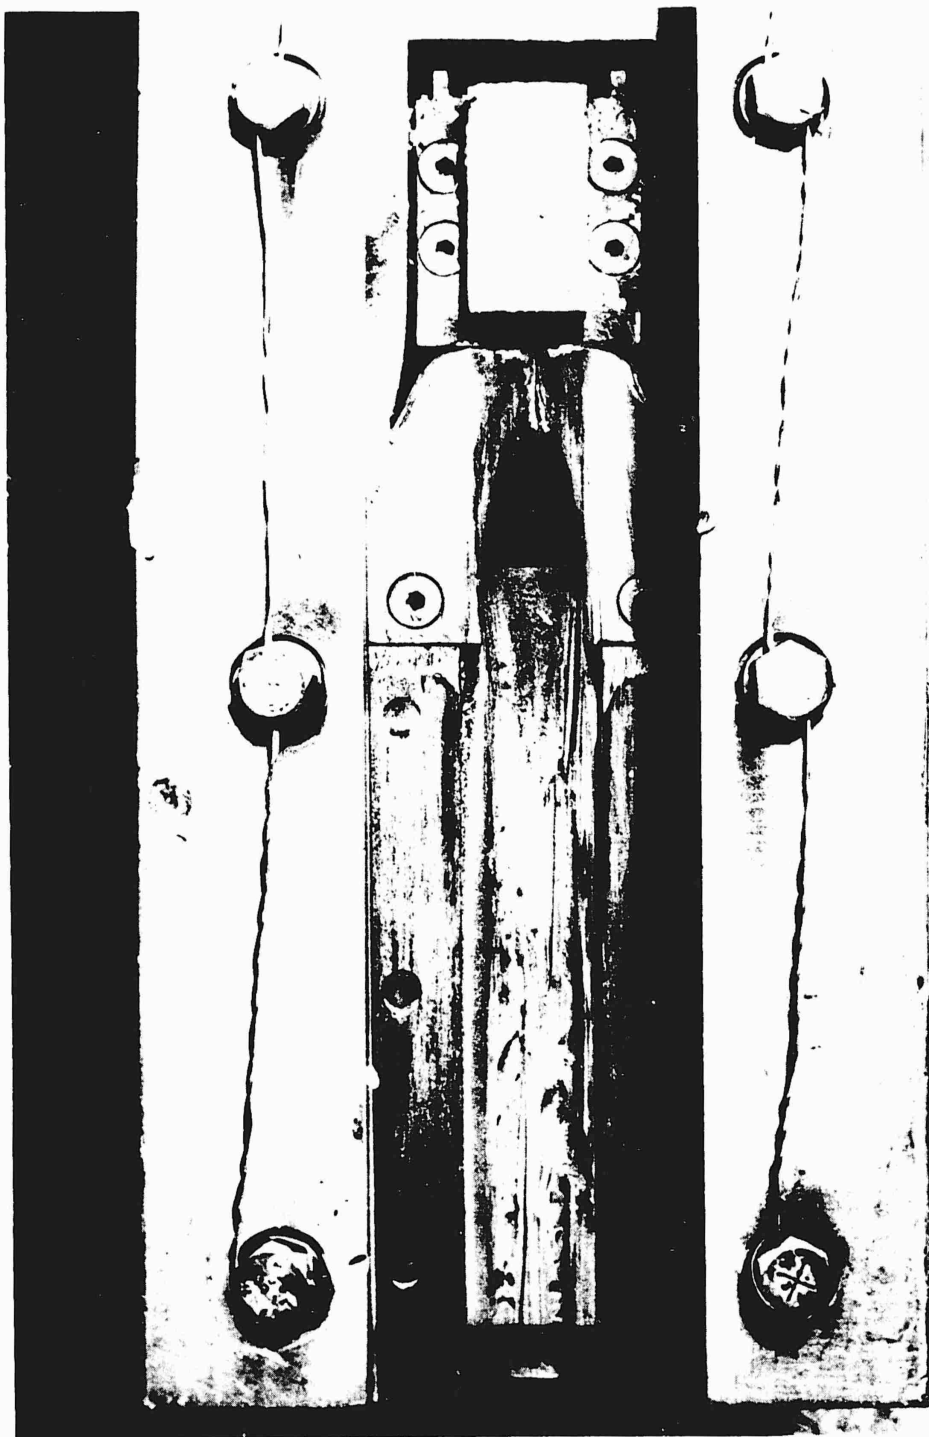
FIGURE 23. Top Bearing Surface of SRI Test Slipper After Lead Coating Test

Note erosion caused by lead.

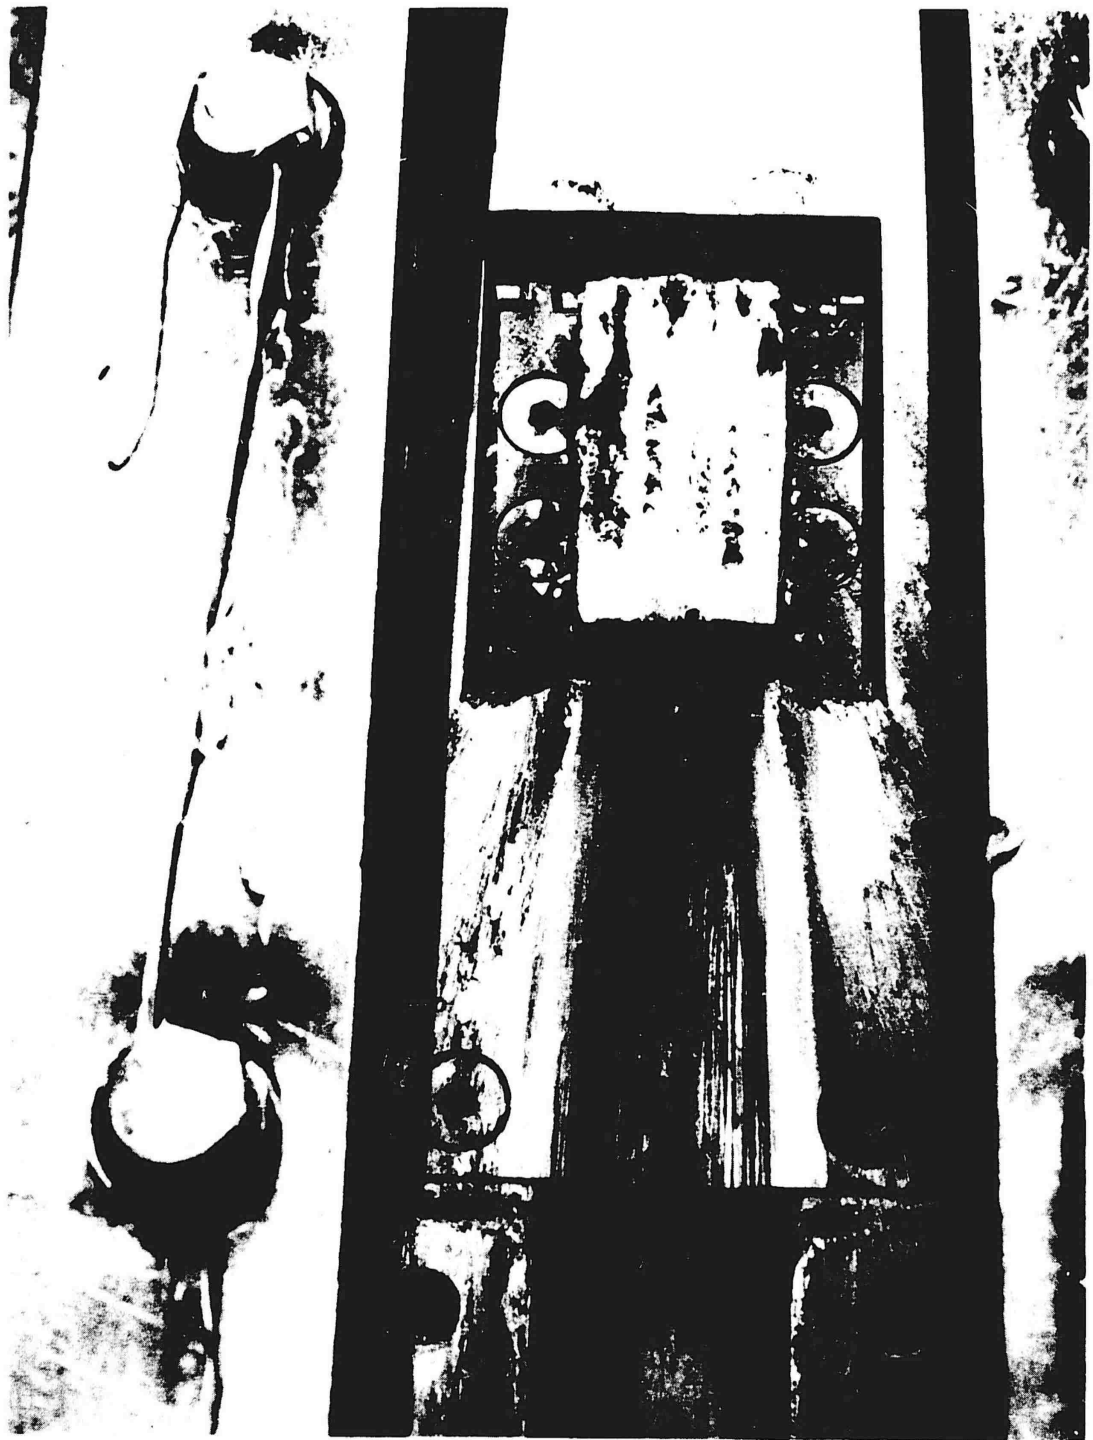
FIGURE 24. Top Bearing Surface of SRI Test Slipper After Lead Coating Test  
Note erosion caused by lead.
